CITA Topic Area E meeting
Stuttgart, 27th of March 2024

Supervision of PTI in Slovakia (new procedures)

Jaroslav Olexa, head of supervision dpt.

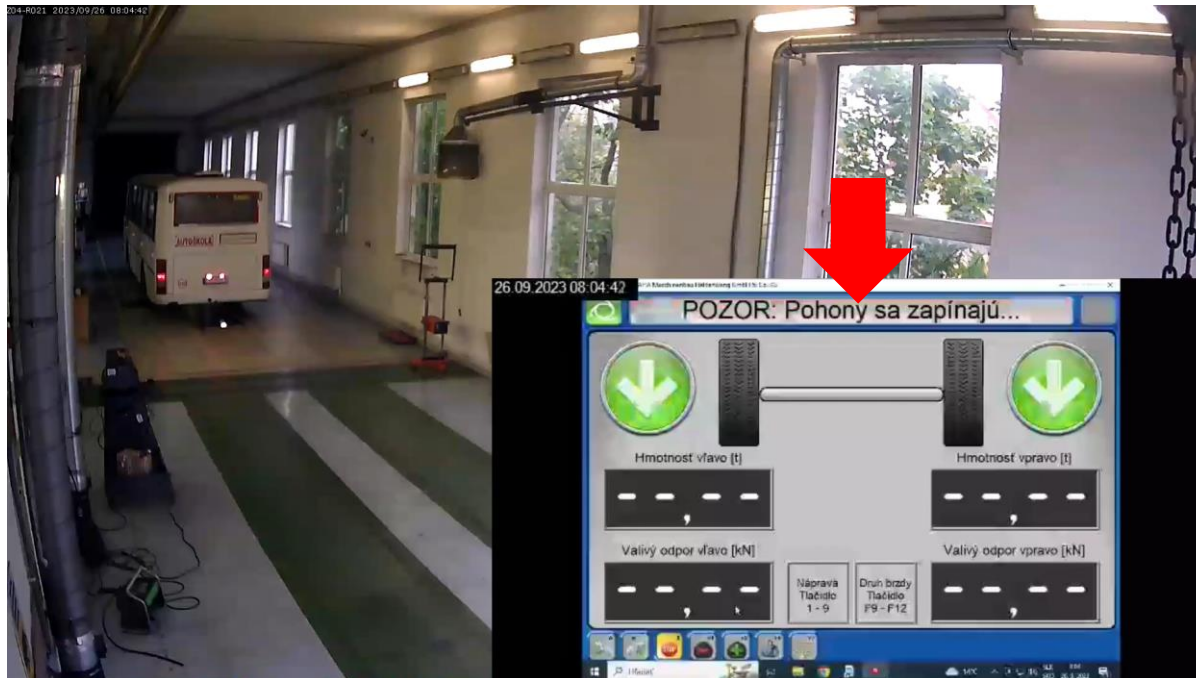
measurement of brake force imbalance in **not-transmitted** measurements (parameter in red)

Vehicle (bus) of the **driving school** (major defect on rear brakes - brake force imbalance over 30%)

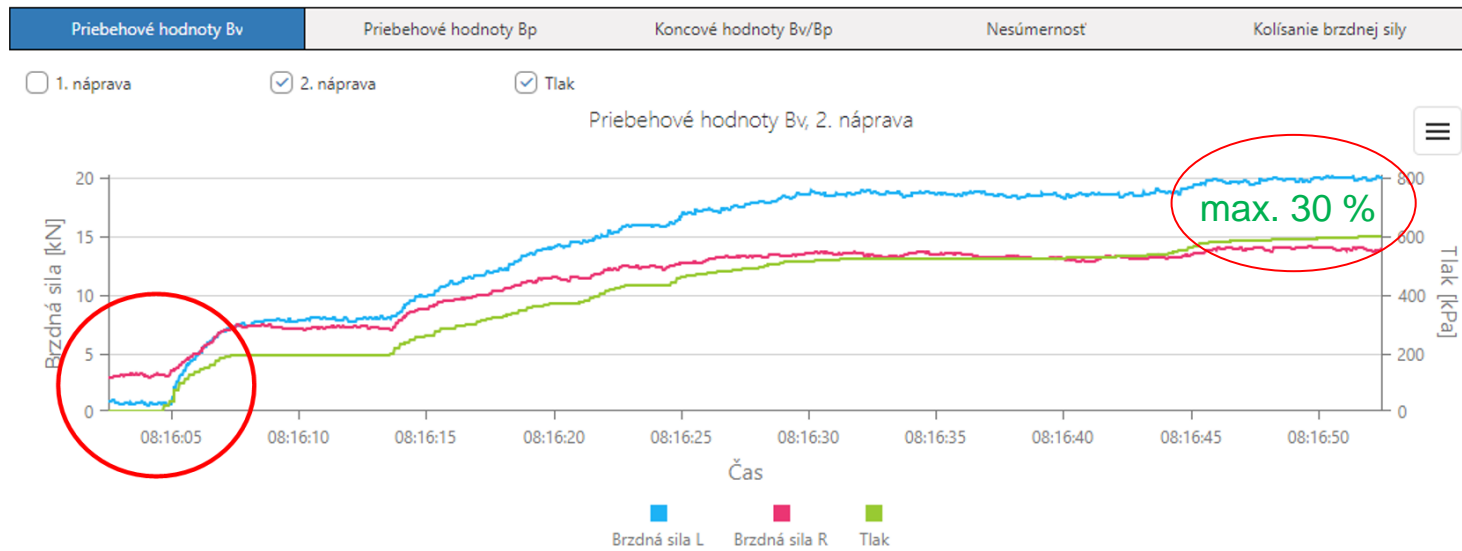
transmitted measurements (first value of brake force on right wheel is almost 3 kN)

Braking force at the beginning of the measurement caused by the intervention of the vehicle owner in the braking system (to **decrease** brake force imbalance **under** 30%)

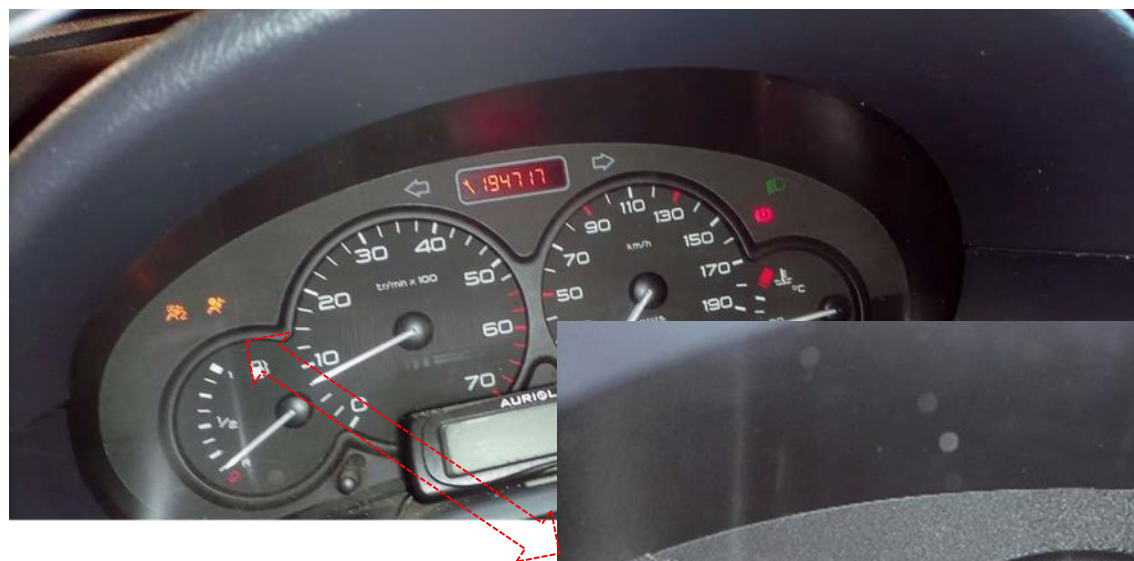
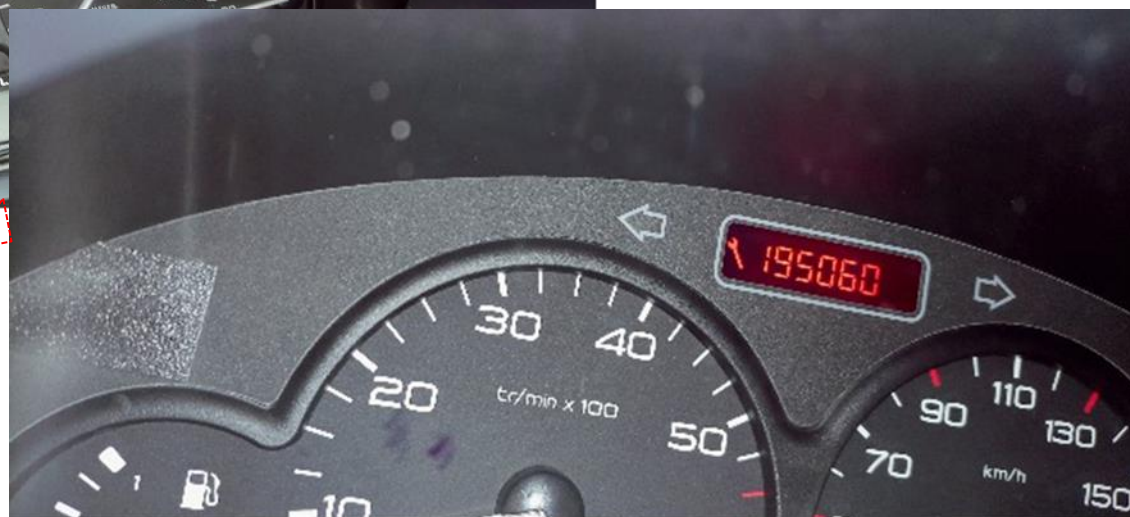
In 2023 we introduced **mandatory** picture of dashboard results: (an attempt to cover up an airbag malfunction)

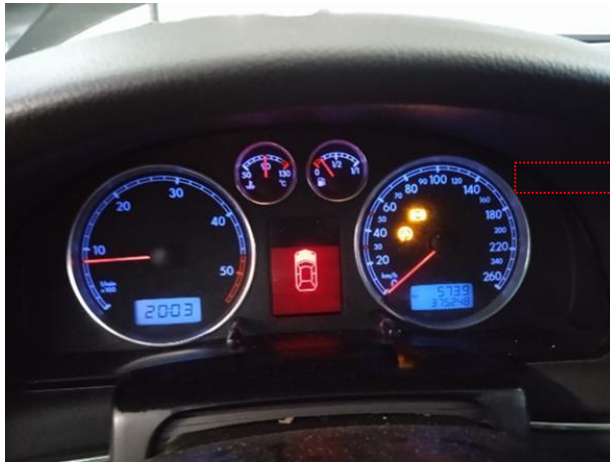
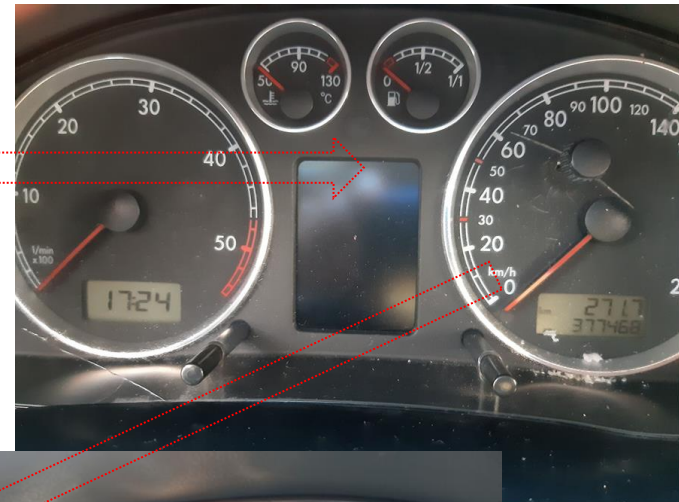
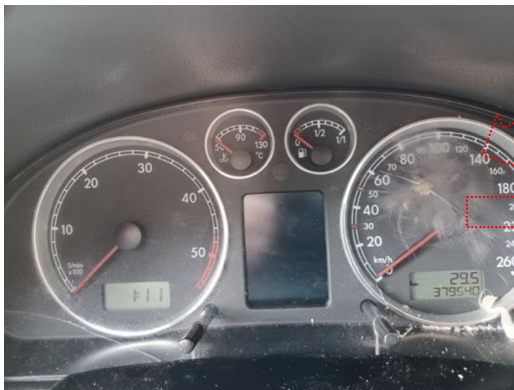
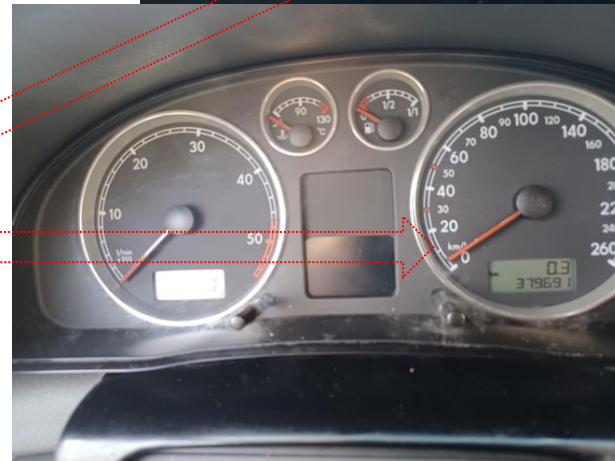
results: (an attempt to cover up an ABS malfunction – regular inspection + 3 repeated inspection)

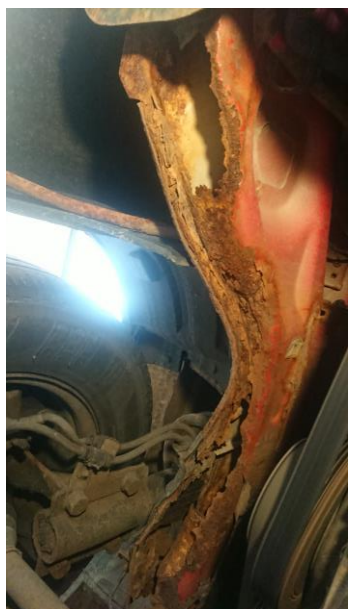
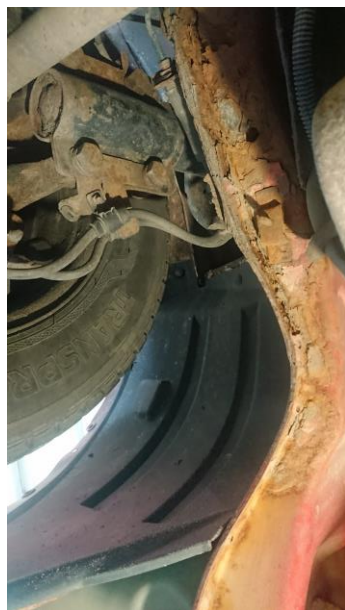
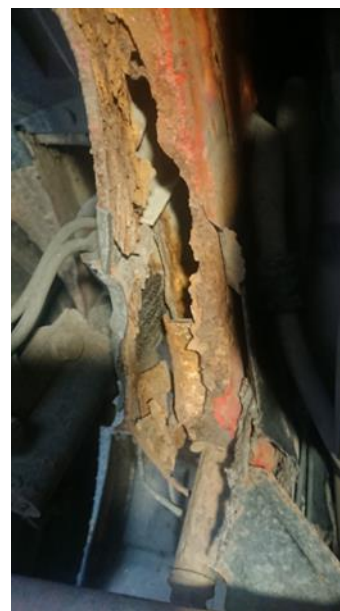
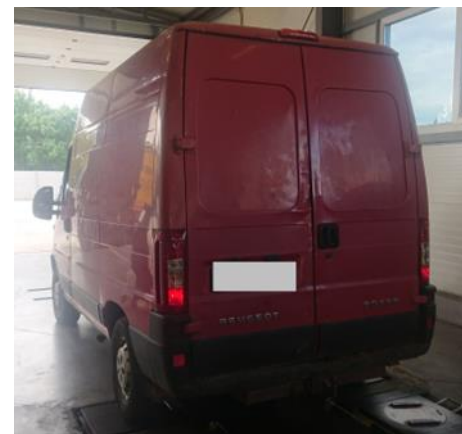
- **corrosion**

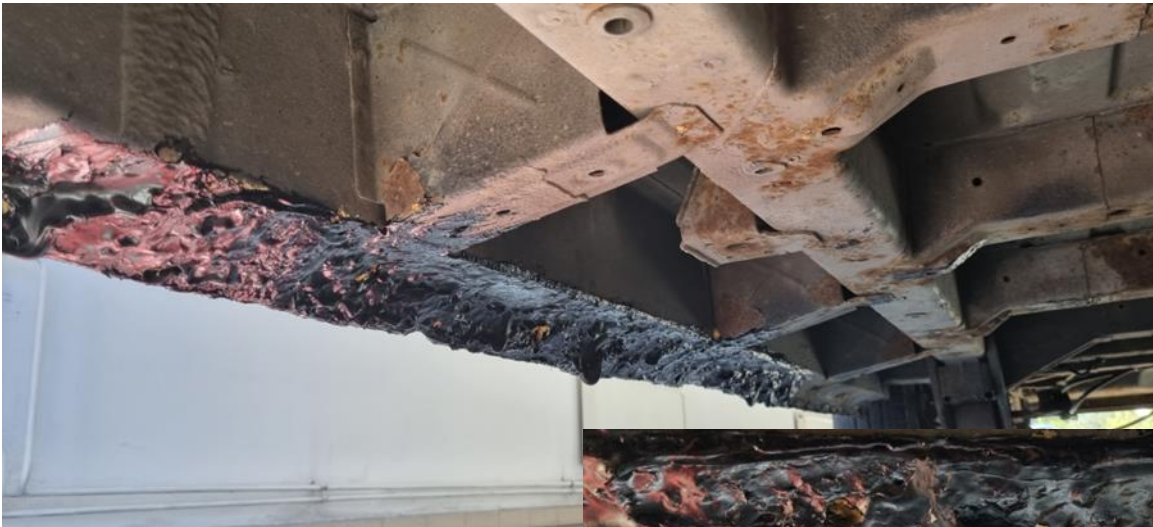
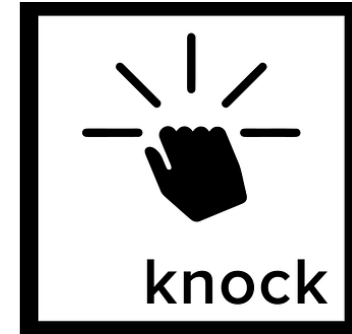
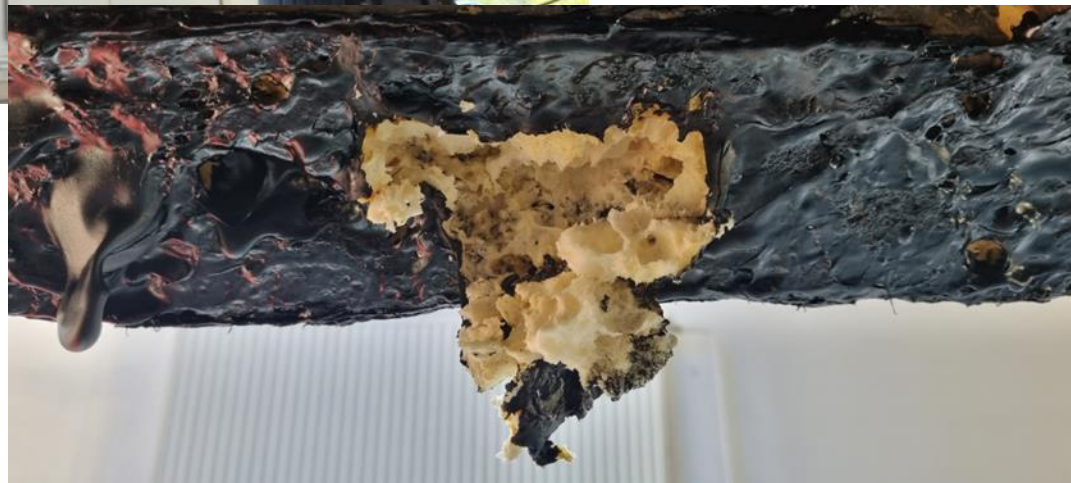
- corrosion

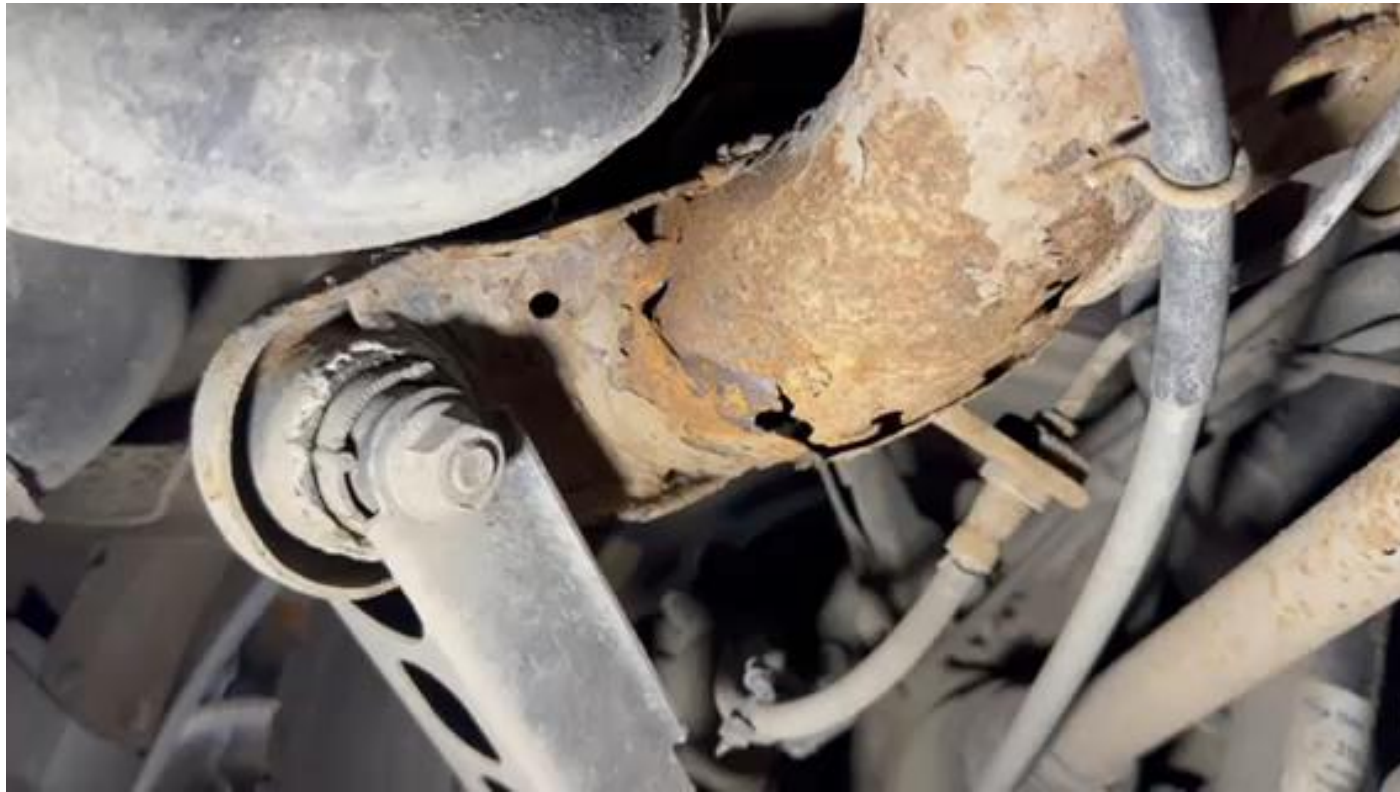
- corrosion

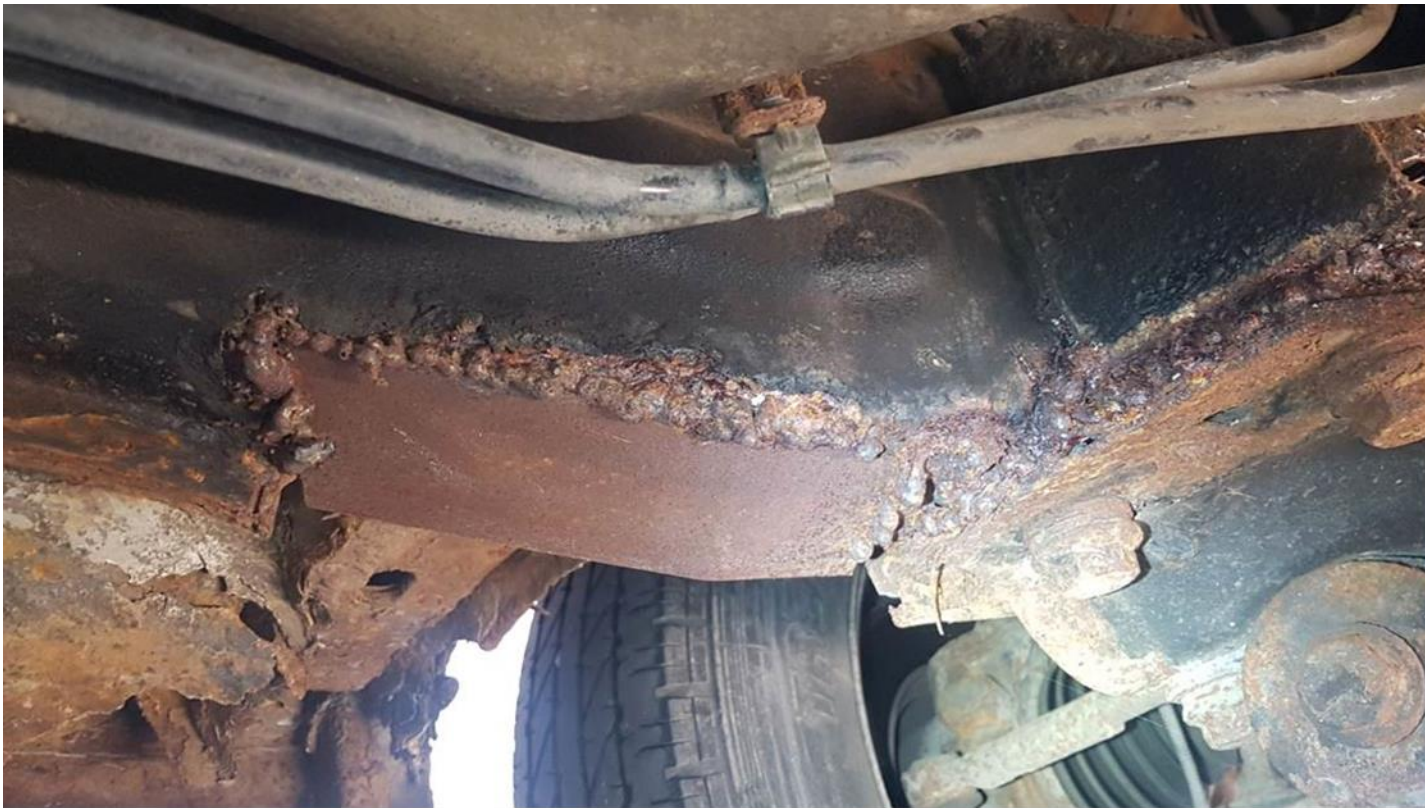
- corrosion (amateur repair)

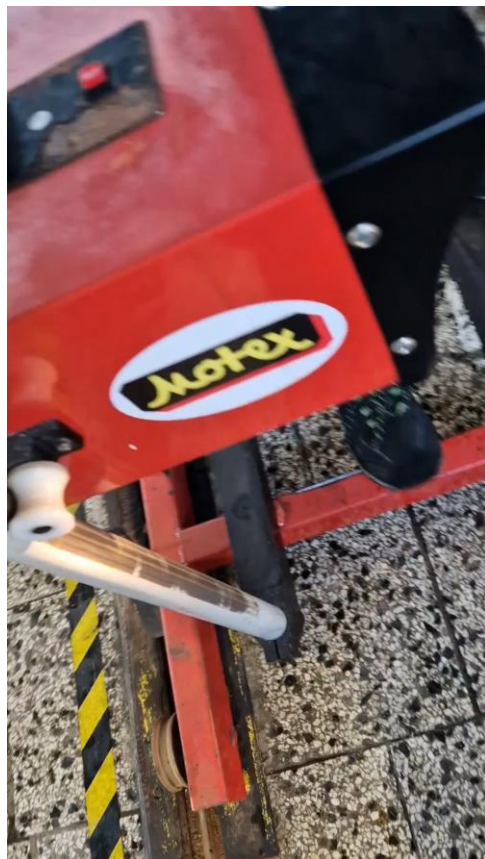
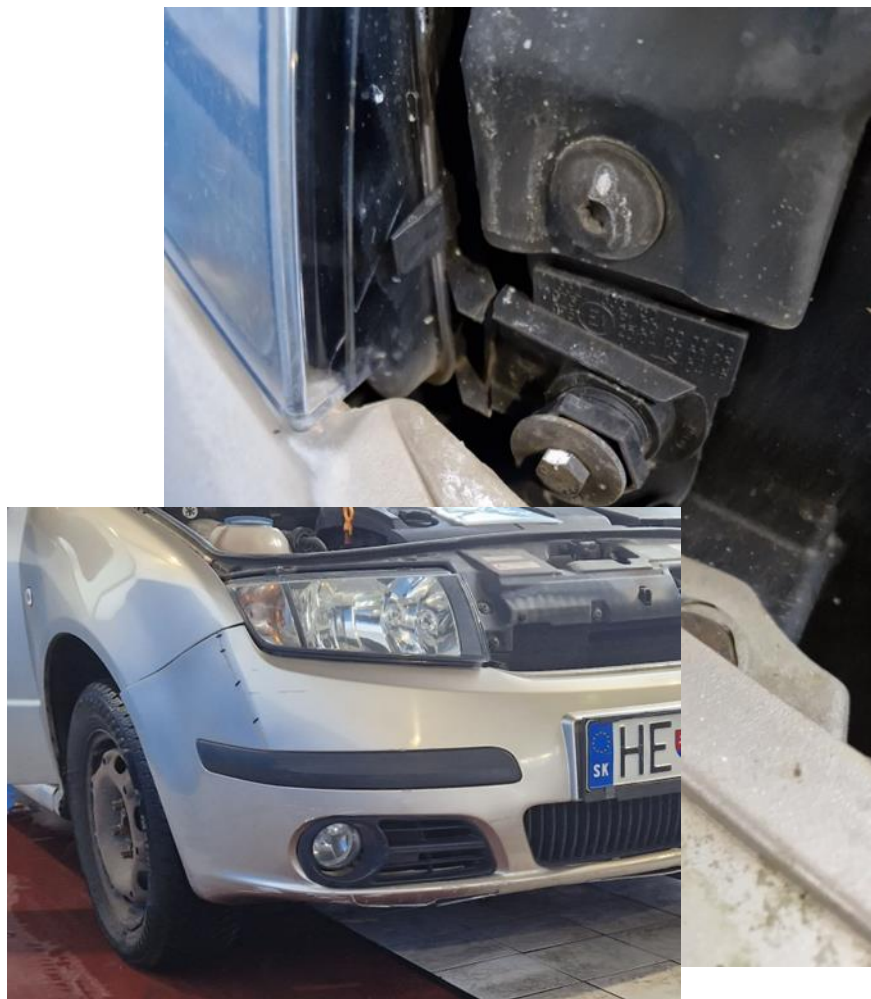
- dipped beam headlights

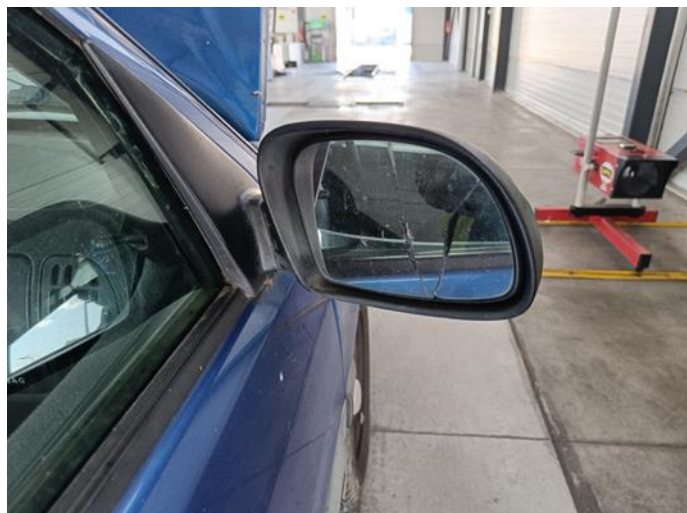
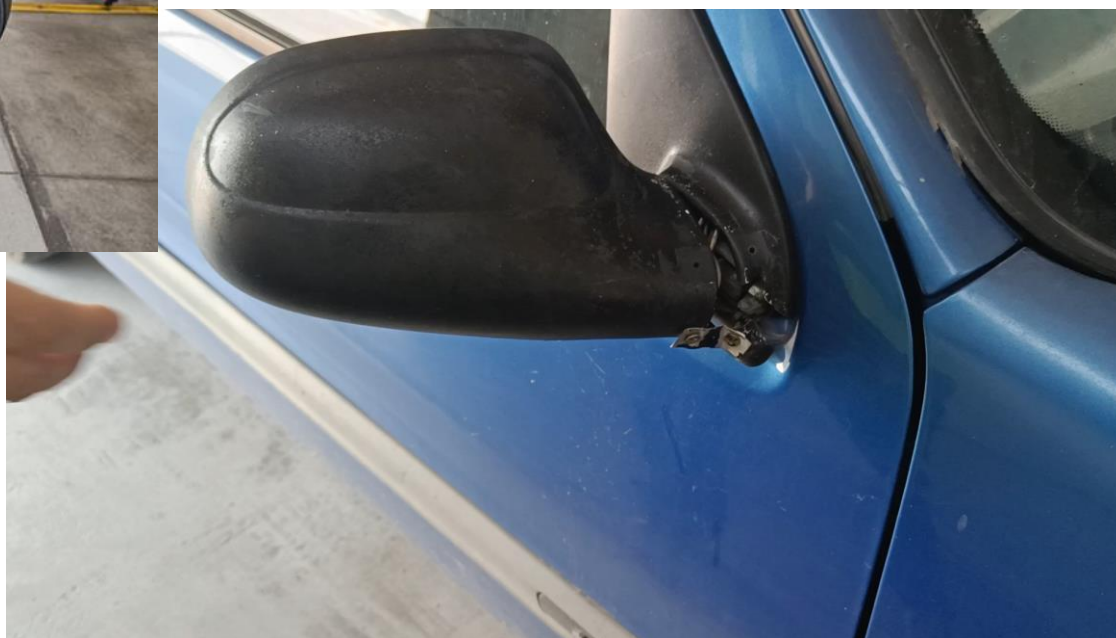
- rear view mirrors

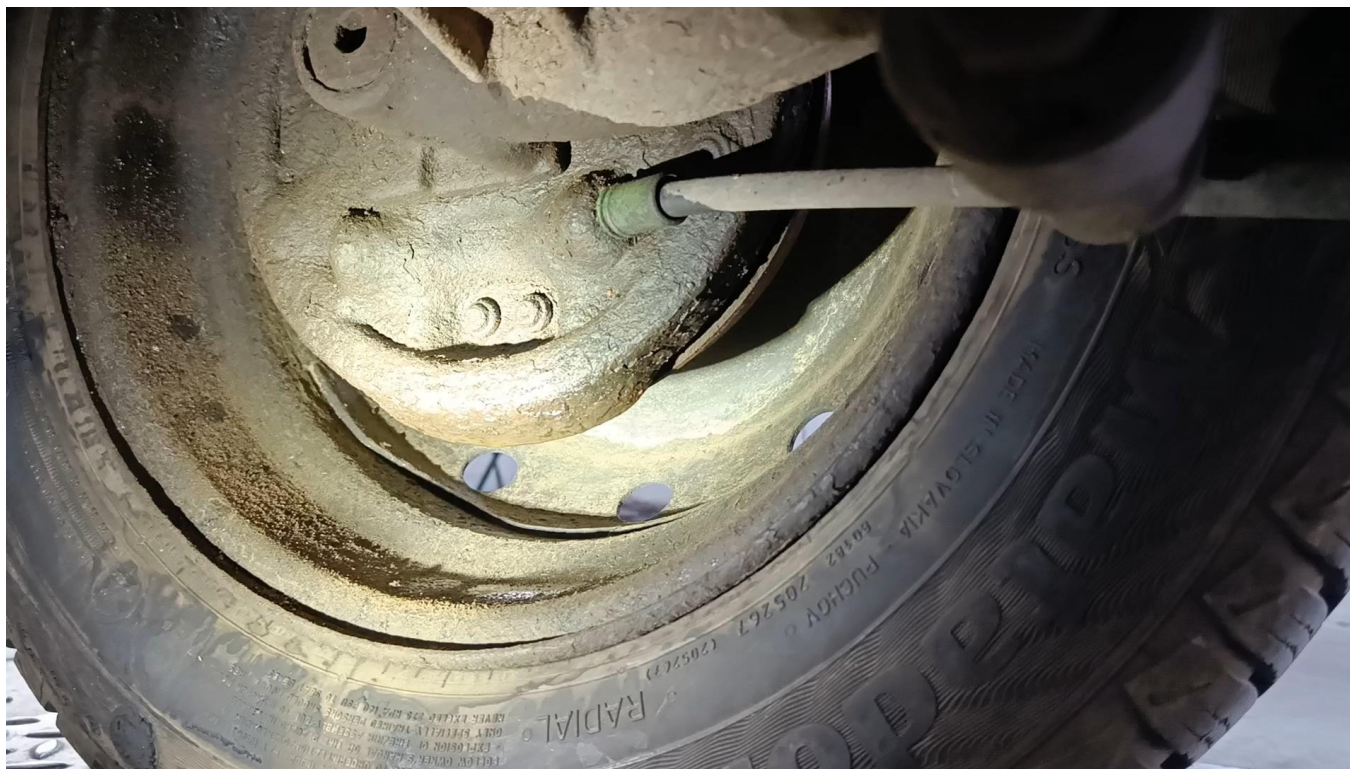
- brake fluid leak

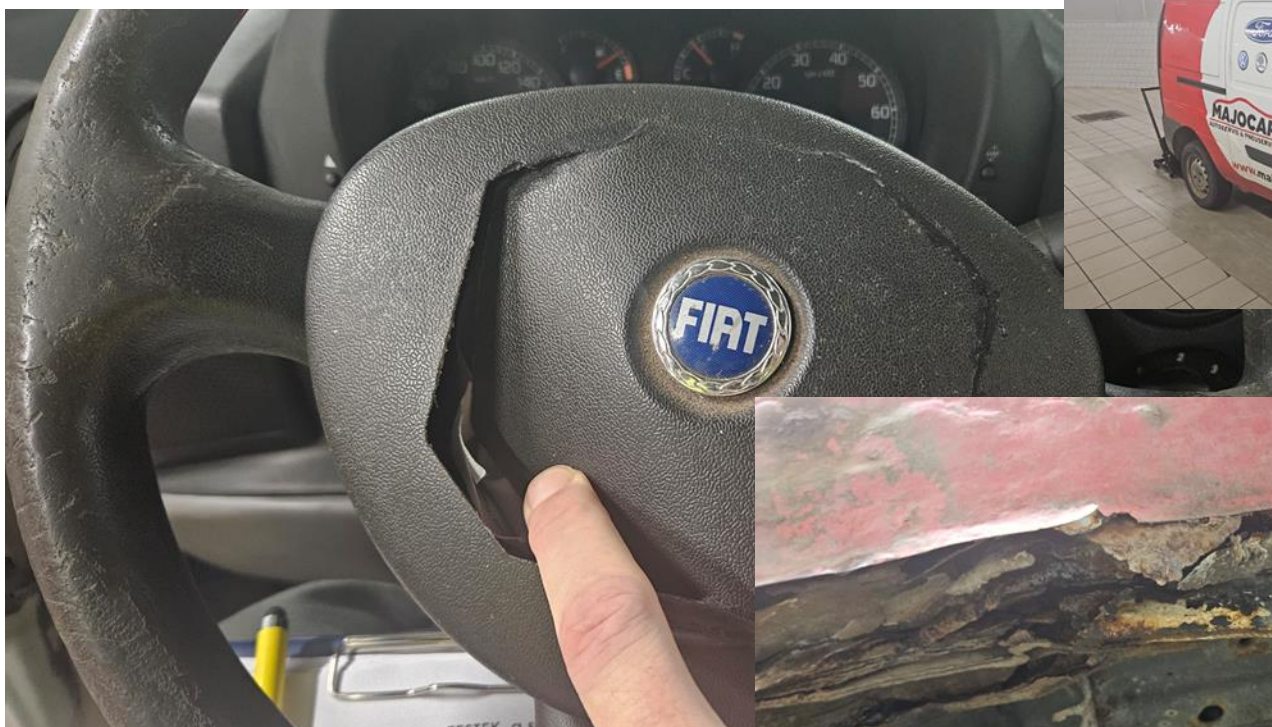
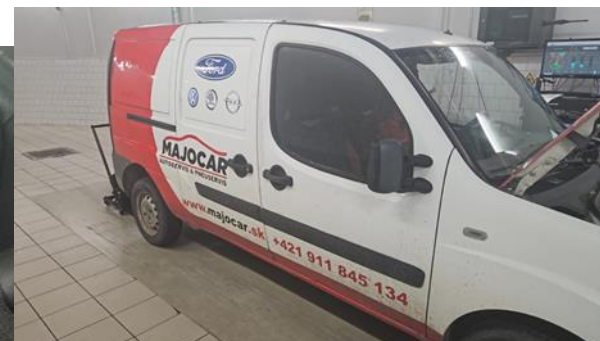
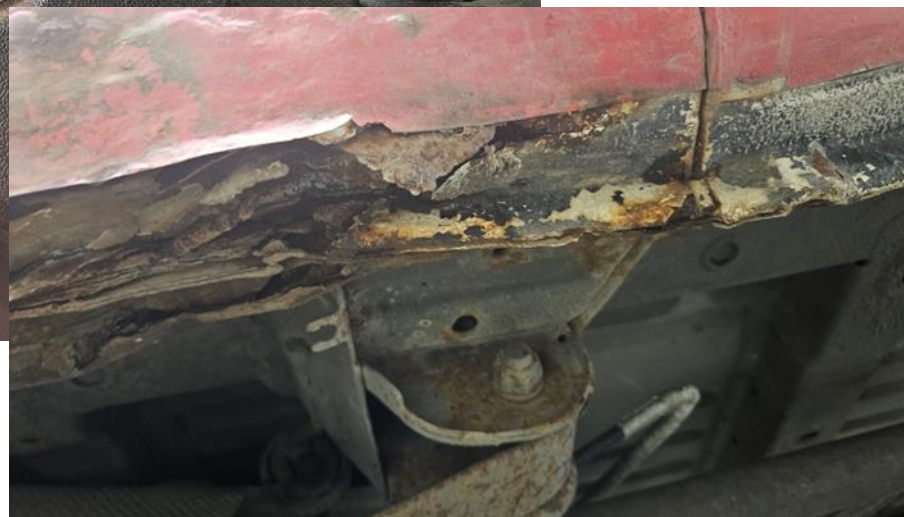
- absence of an airbag (activated) + corrosion

Vehicle owned by
a car **workshop**...
